EM 1110-2-2002

30 June 1995

Engineering and Design
EVALUATION AND REPAIR OF CONCRETE STRUCTURES

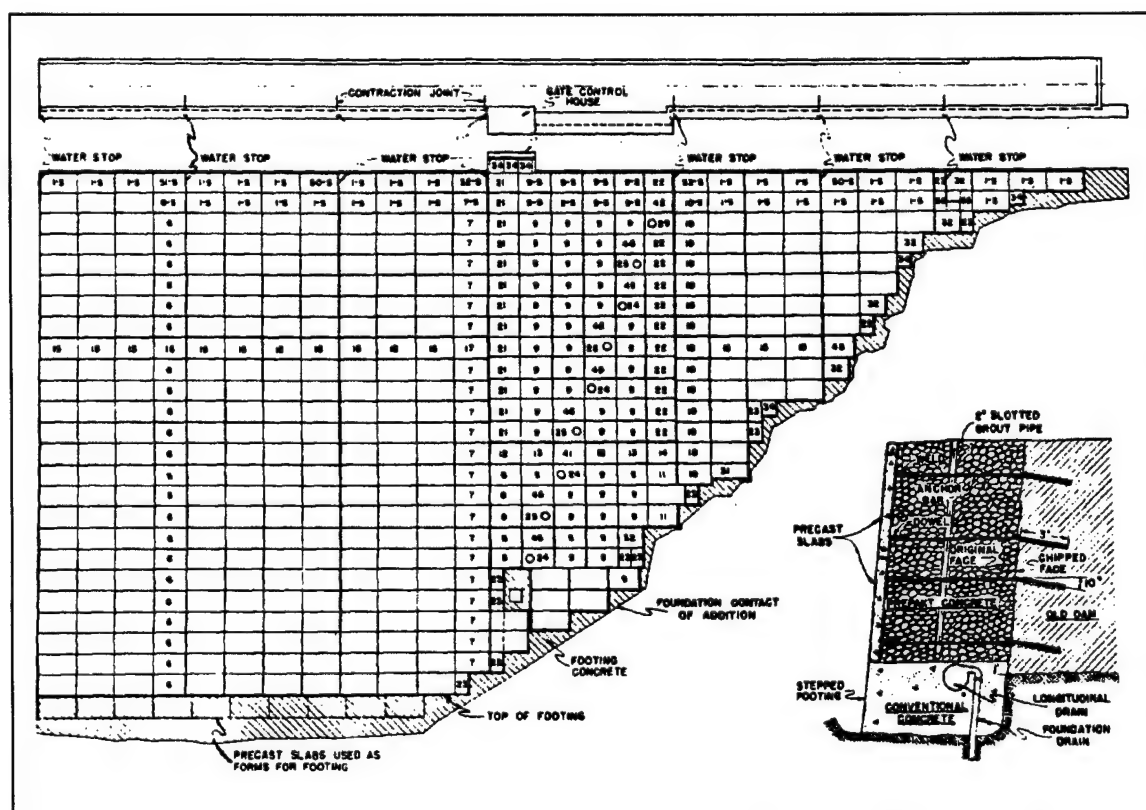
Figure 8-38. Footing and slab layout, south half of Barker Dam (from Davis, Jansen, and Neelands 1948)

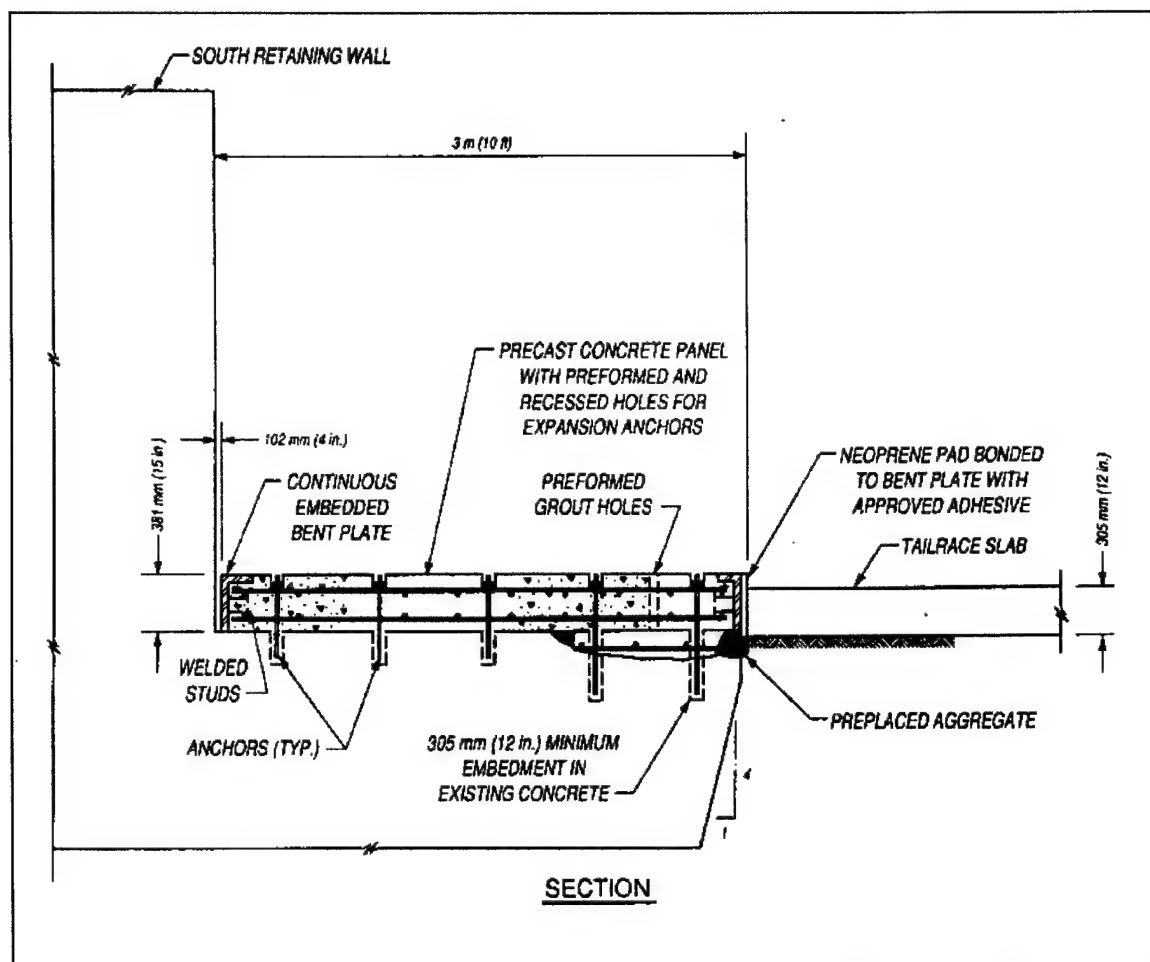
Figure 8-39. Underwater repair of concrete spalling, Gavins Point Dam

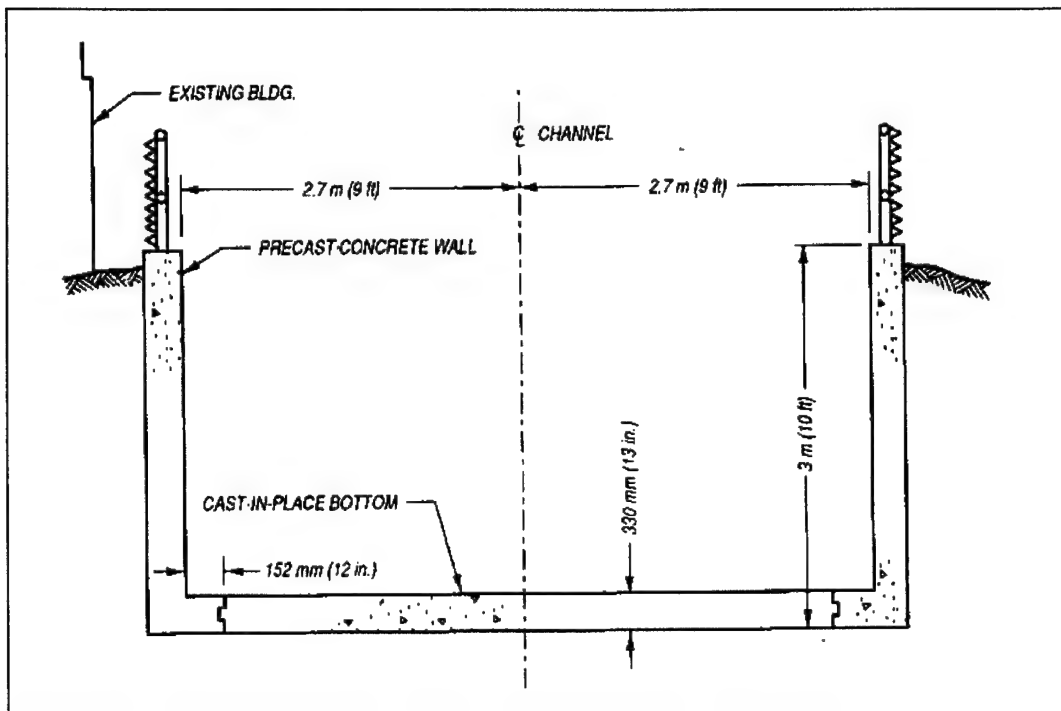
Figure 8-45. Typical channel repair section, Placer Creek (after Hacker 1986)

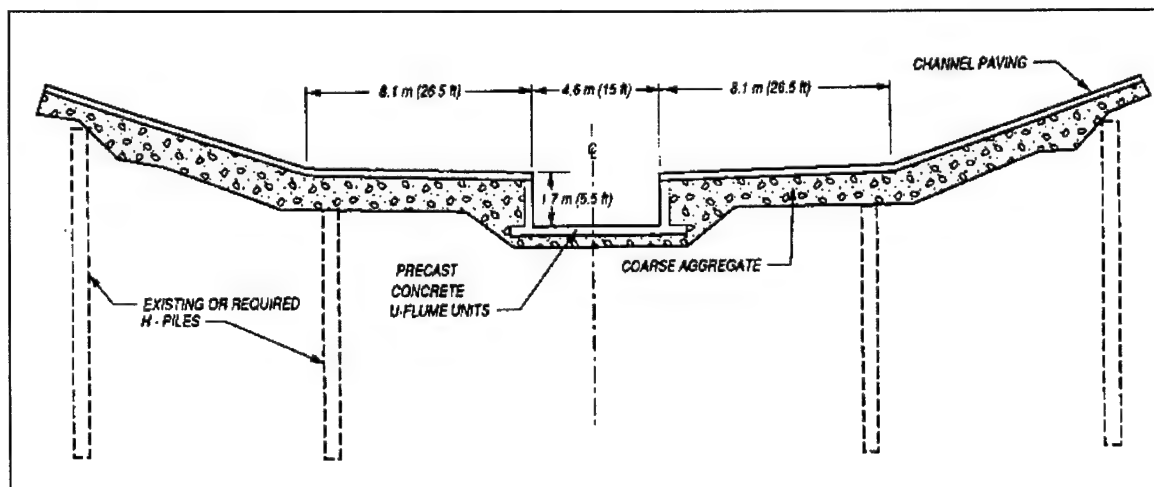
Figure 8-46. Cross section of precast low-flow channel, Blue River Channel (after Mitscher 1992)

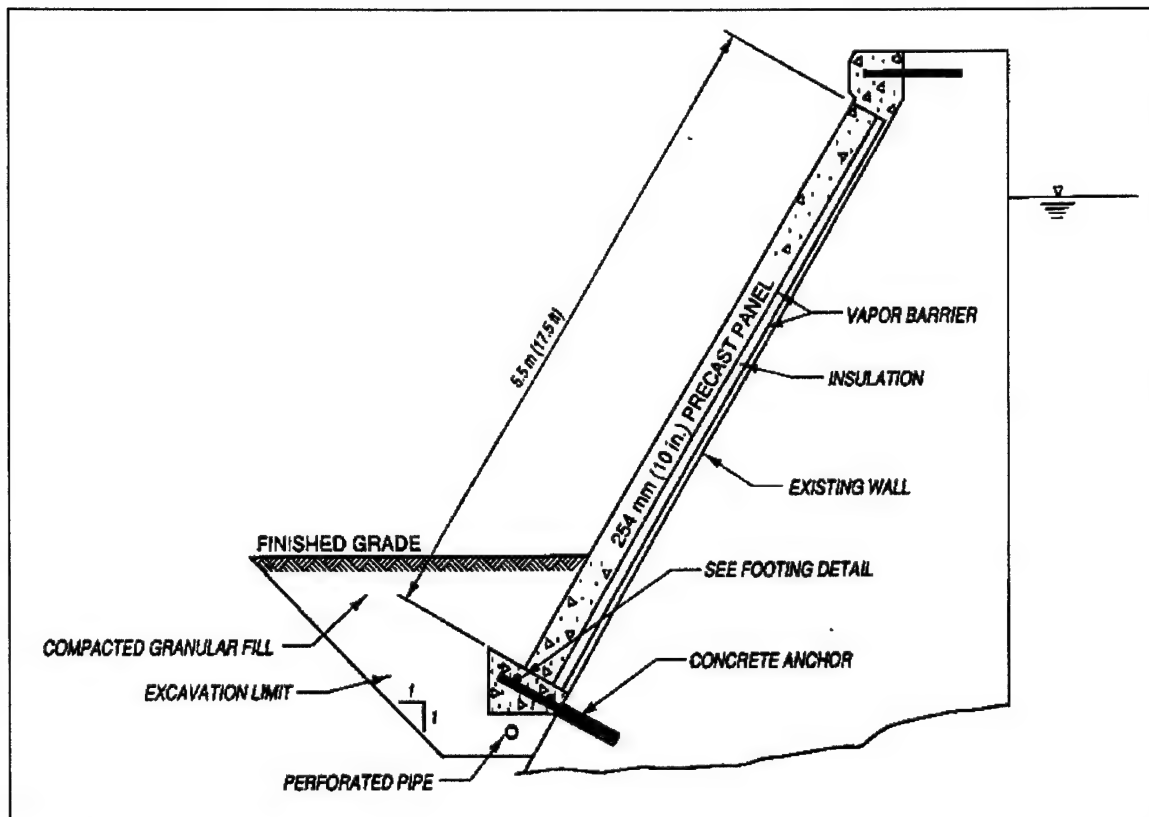
Figure 8-49. Typical repair section, Joliet Channel Wall

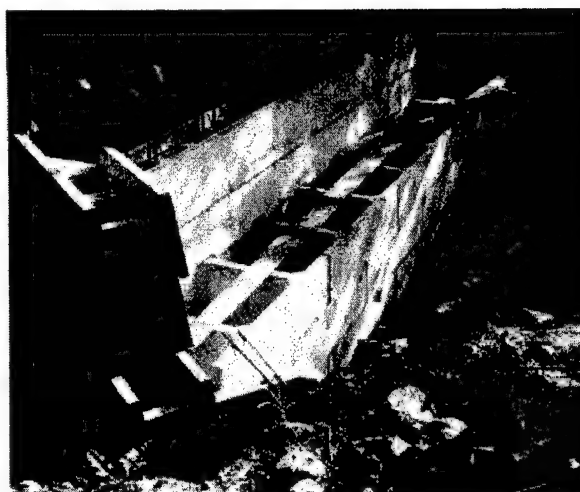
Figure 8-51. Top view of precast abutment prior to backfilling, Ulsterville Bridge

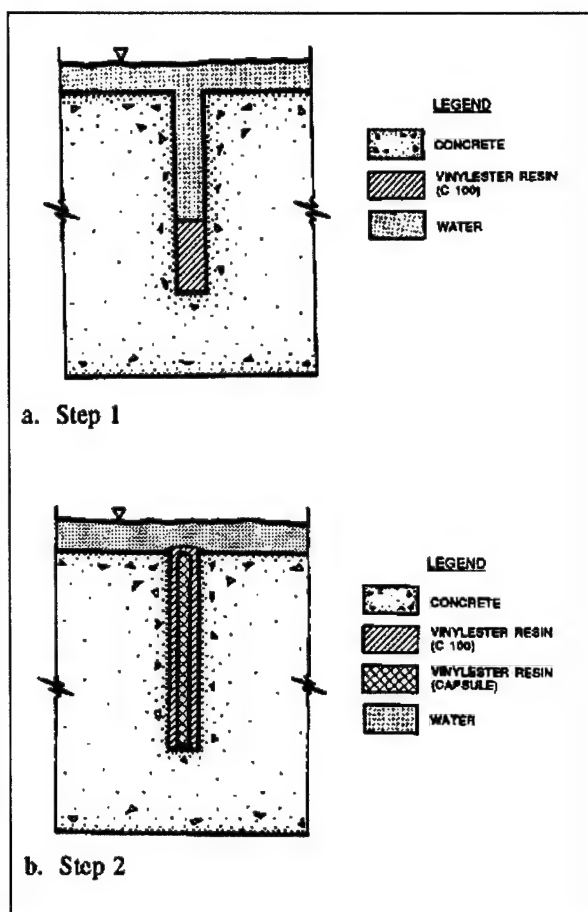
Figure 8-56. Two-step procedure for anchor installation under submerged conditions

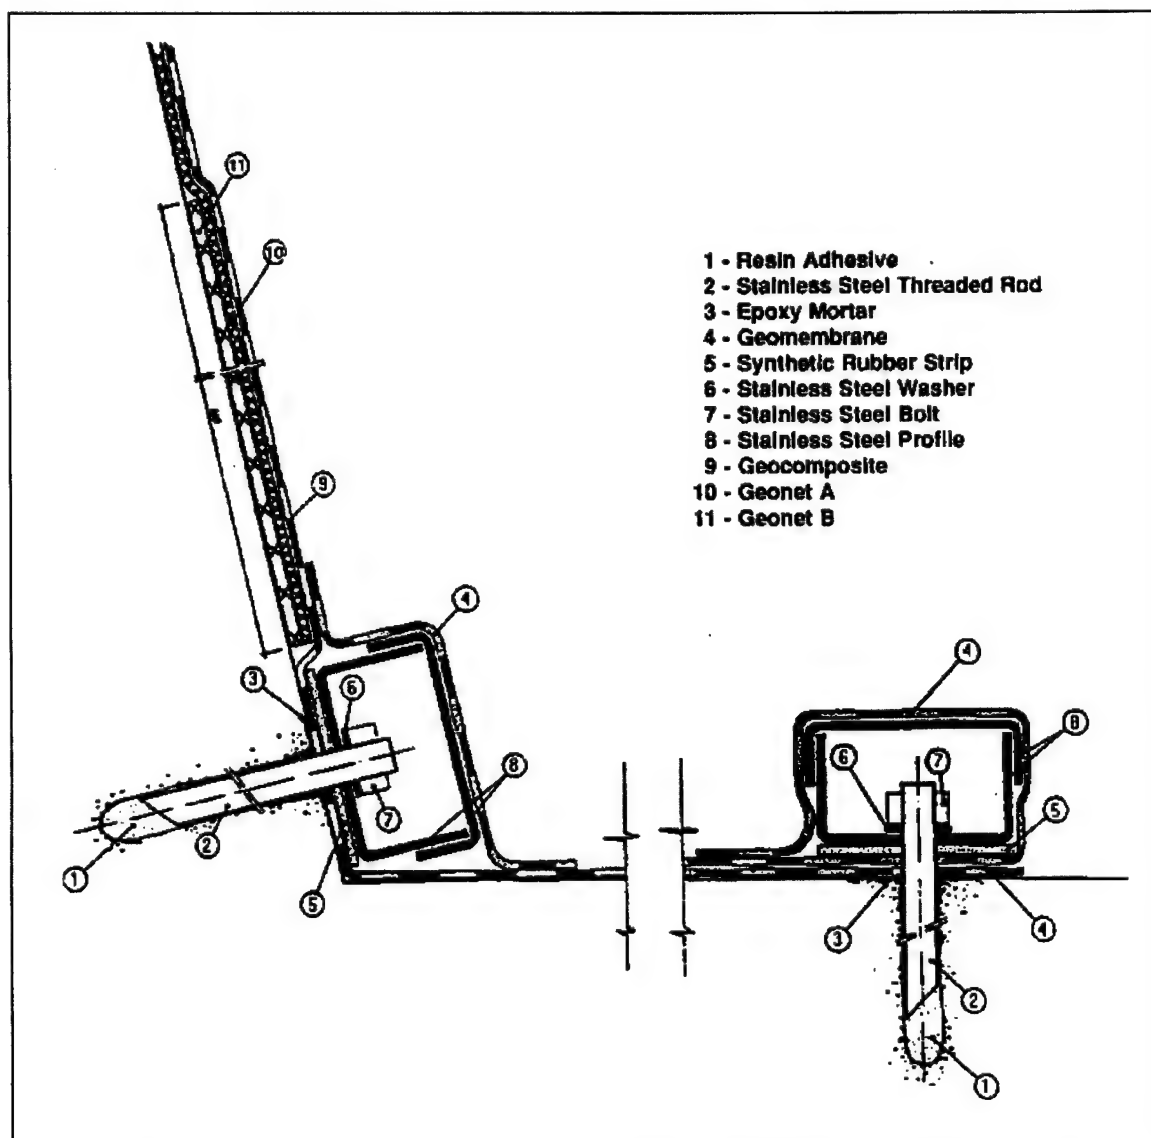
Figure 8-59. Detail of sealing profiles

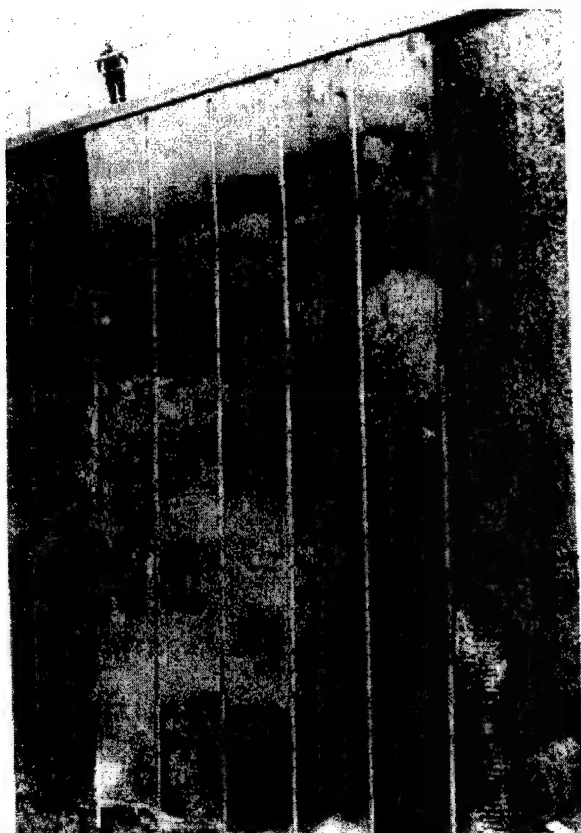
Figure 8-61. Steel profiles embedded in shotcrete, Cignana Dam

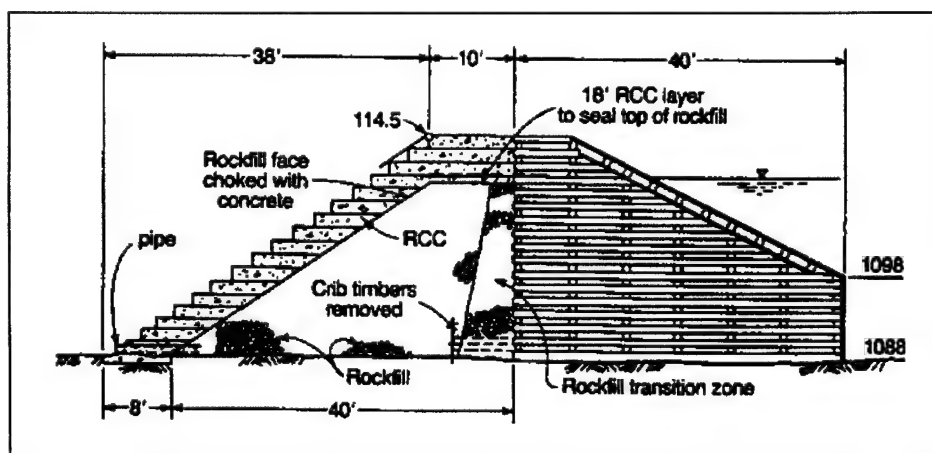
Figure 8-63. Section through modified dam, Ocoee Dam No. 2 (Hansen 1989)

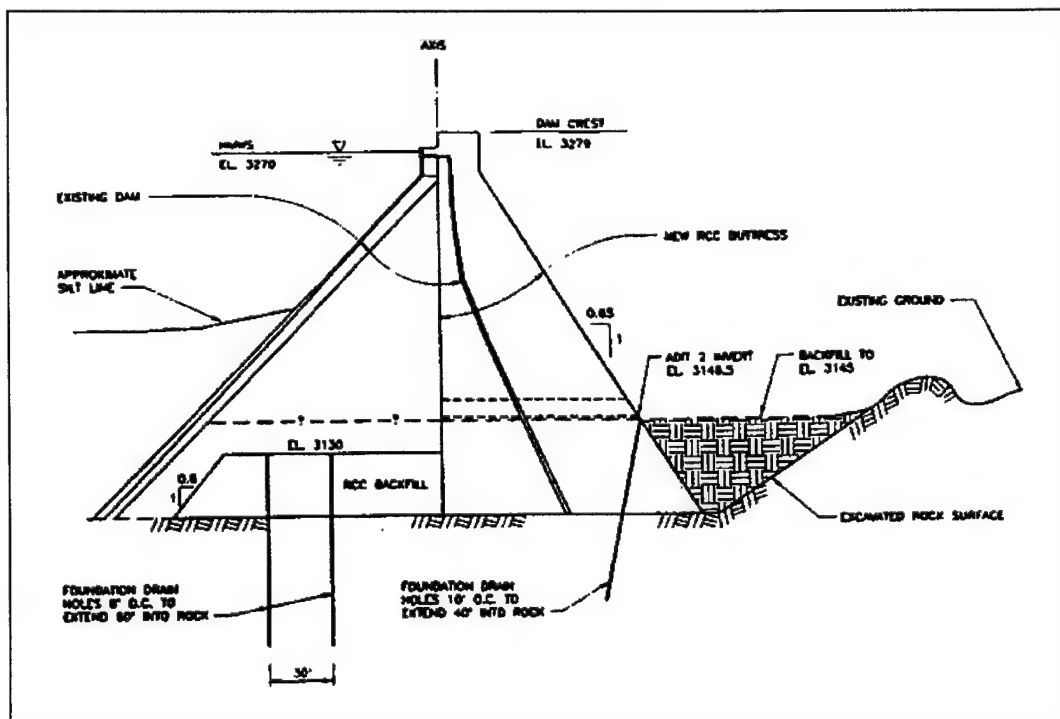
Figure 8-70. Littlerock Dam modification (Bischoff and Obermeyer 1993)
